Maryland Historical Trust State Historic Sites Inventory Form

1. Nam	e (indicate pr	eferred name)		
historic Wil	liam James Dobs	on House		
and/or common				
2. Loca	tion			
street & number	Fairbank Roa	d		not for publication
city, town	Fairbank	vicinity of	congressional district	Fifth
state	MD	county	Talbot

7. Description			Survey No. T-822	Survey No. T-822
Condition excellentX good fair	deteriorated ruins unexposed	Check one unaltered _X_ altered	Check one original site moved date of move	move

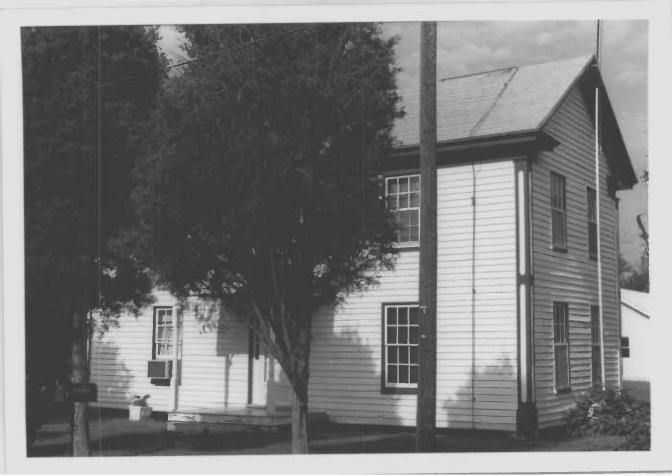
Um James Dobson House 7-824

NE elevation

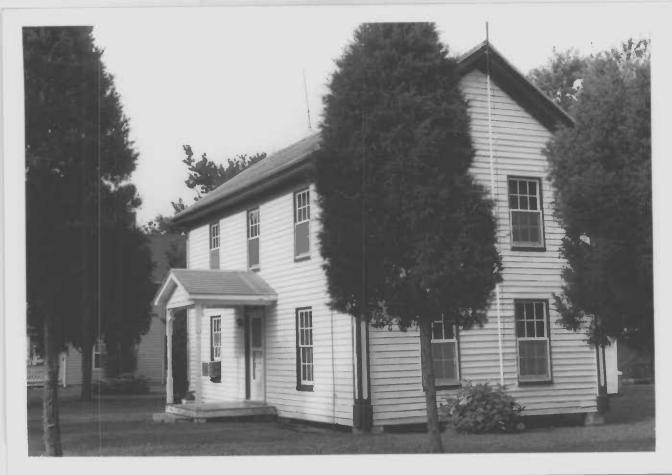
JULIAN JAMES DOBEN 18-53 T-822
Tilghman Tistand, Tallbot County, 110.

NORTHEAST ELEVATION
